Hyundai Steel BF3 Bosh Repair

Summary

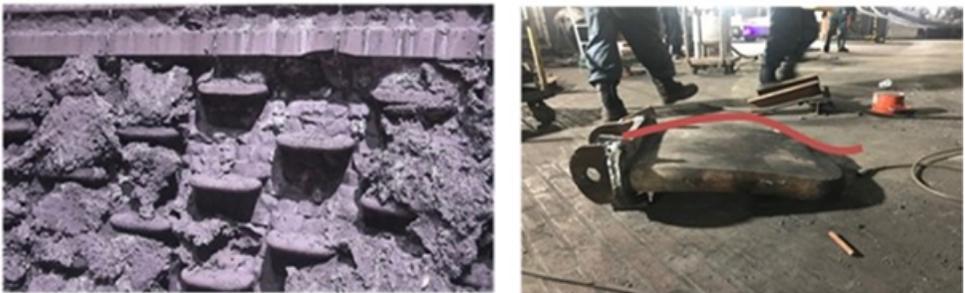
Deterioration of a silicon carbide bosh lining will furthermore expose the copper plate coolers to aggressive operating conditions. This can cause copper plate coolers deformation and burn-outs. Ultimately the BF shell will be exposed to high temperatures causing hot spots, deformation and cracks. These phenomena have been occurring at Hyundai Steel BF3 and are illustrated in Figure 3.

Figure 3: Bosh Refractory and Copper Plate Cooler Failures

BF3 premature failure of copper staves in the belly and lower stack already necessitated replacement of two rows thereof in 2018. The bosh silicon carbide lining also deteriorated significantly within a few years after commissioning causing leaking copper plate coolers and shell hot spots. Shotcreting in 2019 provided temporary protection, but repeating shotcreting would compromise Hyundai Steel operating KPI's and it was therefore decided to execute a 20-day campaign extension repair in 2021.

The 2013 bosh silicon carbide lining deteriorated significantly within a few years after commissioning. This caused leaking copper plate coolers and shell hot spots. Shotcreting in 2019 provided temporary protection, but repeating shotcreting would compromise Hyundai Steel operating KPI's and it was therefore decided to execute a 20-day campaign extension repair in 2021. The tuyere ring and bosh design have been upgraded to graphite and modern copper plate coolers. The mid-campaign repair also included replacement of one row of copper staves.

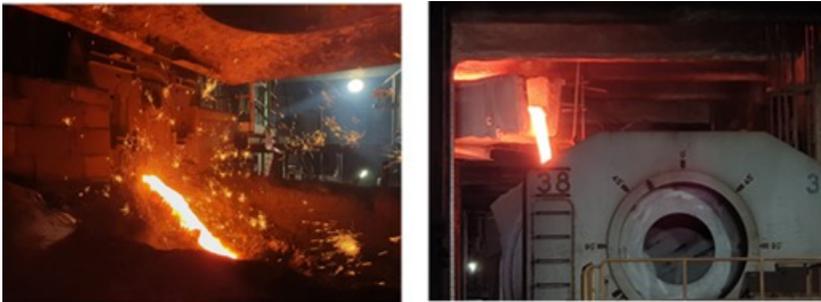
The successful blow-down of Hyundai Steel BF3 has been initiated on March 23rd, 2021. Salamander tapping was made thereafter into multiple torpedo's. The total amount of salamander tapping liquid hot metal has been approximately 1100 tons (Figure 8).

Figure 8: Salamander Tapping

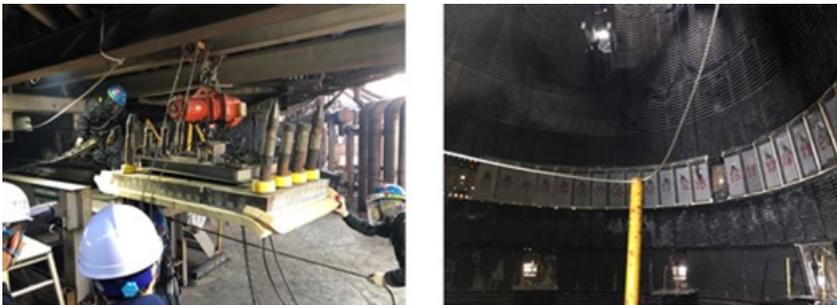
Figure 9: Replacement of Row S3 Copper Staves

The bosh copper plate coolers could be removed after salamander tapping and S3 row copper staves (56 pieces) could be replaced without people entering the BF. Replacement of the copper staves was done very efficiently through four access doors and using four temporary monorails (Figure 9).

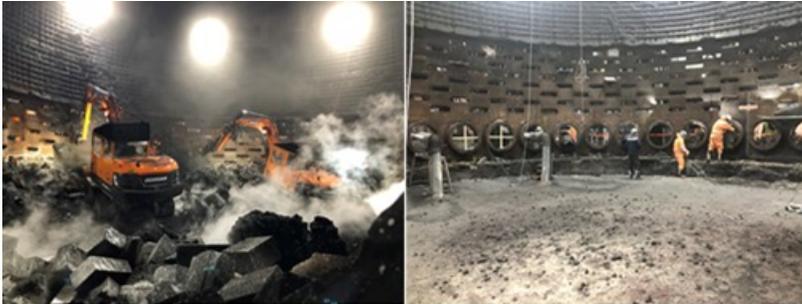
Figure 10: Demolition and Capping Layer

A large shell portal was then cut to allow for entry of two demolition machines to remove the remaining coke, burden and refractory. No quenching was made as this would cause a risk of phreatic explosions of the ultra-micropore carbon block at blow-in. Instead a slag sand and castable capping layer was installed on the remaining

burden in the hearth. This capping layer ensures safe working conditions for people inside the BF and it acts as the temporary foundation for the working platforms. Four vent lines were routed through the shell to remove any CO gas which could be created underneath the capping layer. The two demolition machines and the capping layer are illustrated in Figure 10.

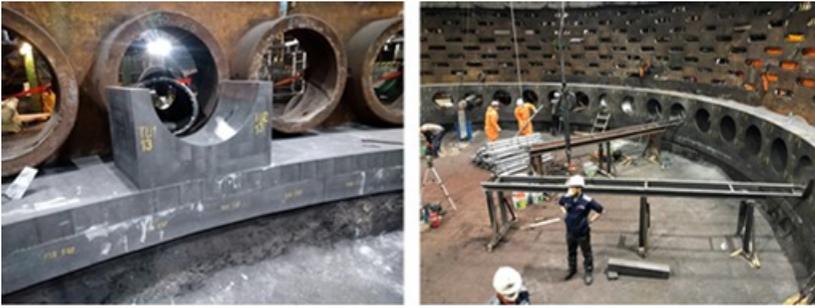
Figure 11: Installation Tuyere Ring

Installation of the tuyere ring could start within 200 hours after start of the blow-down procedure. A leveling course was necessary to ensure that the tuyere ring graphite blocks could be installed at the right elevation. These tuyere ring graphite blocks are installed dry i.e. without mortar. Figure 11 includes two pictures of the graphite tuyere ring installation. It is also clear that Hyundai Steel has been very successful in securing clean and safe working conditions.

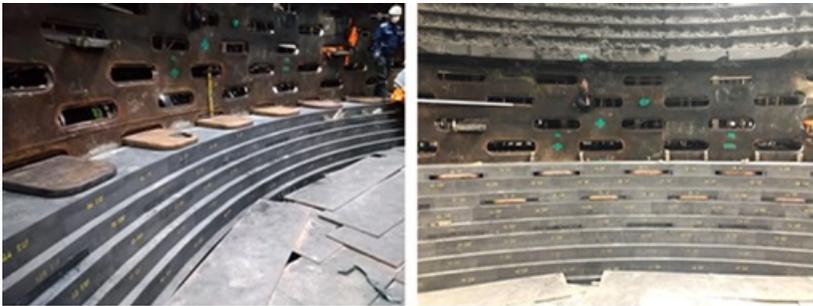
Figure 12: Installation Bosh Graphite and Copper Plate Coolers

The seven rows of new copper plate coolers and the bosh graphite refractory lining could be immediately installed after completion of the tuyere ring. Installation could be executed very efficiently due to excellent logistics and labor personnel.

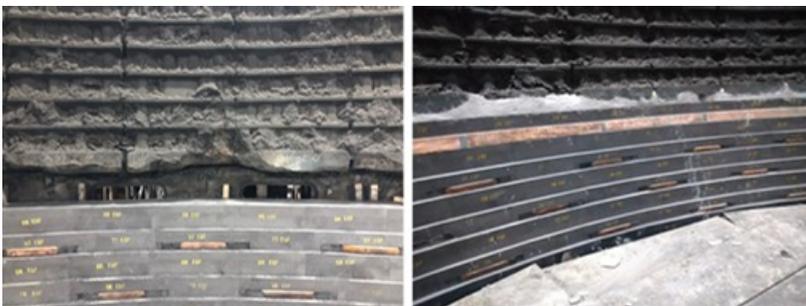
Figure 13: Transition Bosh - Belly

The transition to B2 copper staves is critical as premature deterioration thereof could otherwise cause risk to operations. New MTT copper coolers were therefore designed and installed to provide maximum cooling efficiency of the graphite lining underneath. The lower part of B2 copper staves appeared to have partially degraded and the remaining space was filled with silicon carbide ramming material (Figure 13). Installation of the tuyere ring and bosh could be conducted within 200 hours.
