A Robust Fume Treatment Centre of the Global Aluminium Industry

Peter Klut¹, Travis Turco², Jamal el Filali³ and Edo Engel⁴

Danieli Corus BV, IJmuiden, The Netherlands

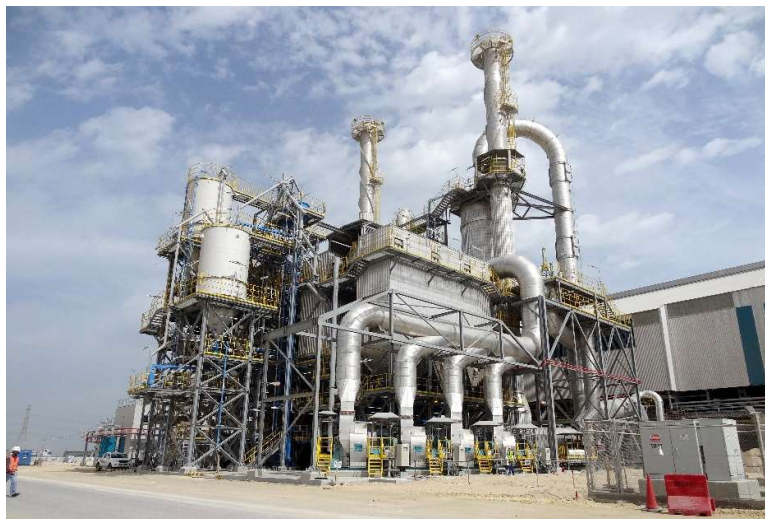
The Fume Treatment Centre designed by Danieli Corus for the primary aluminium smelting sector has shown its robustness and reliability over decades. Now in its fifth generation the Pleno design has been updated and improved while retaining its tried and tested design. Pleno V relies on a design dating back to the 1980s that has proved itself over the years, while undergoing improvements in each successive generation. The Pleno V design as seen in figure 1, provides additional platforms, easy access for inspection and maintenance, and isolation points.

Figure 1. Pleno V Fume Treatment Center.

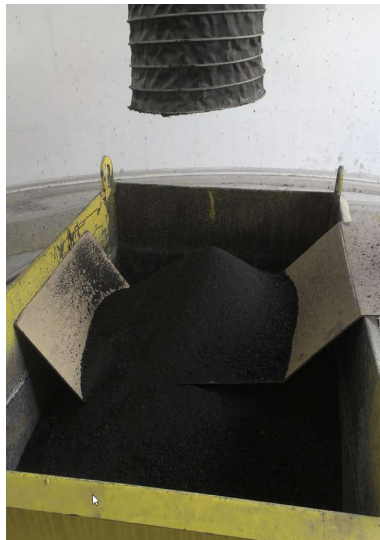
“Dry bottom” operation of the conditioning tower as seen in figure 2, is the operating mode whereby pollutants are discharged at the bottom without containing any moisture. This reduces corrosion risk and makes for a service life of 30 years and more, against typical design life of 20 years.

Figure 2. Separated pollutants with “dry bottom” operation.

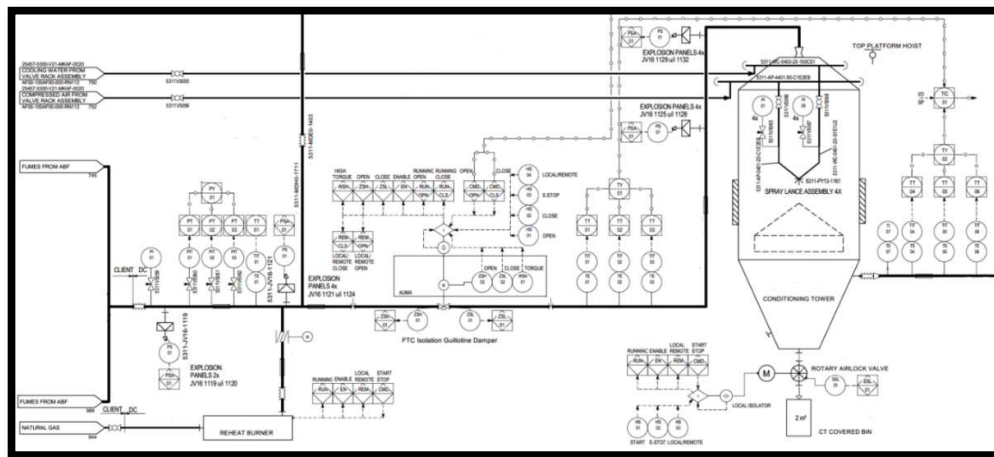
Highly automated temperature control, with three sensors on the inlet and three on the outlet ensure constant temperature, allow total evaporation of the water spray and prevent condensation, ensuring a straight temperature line throughout the process – refer to figure 3. Feed forward control on the quantity of gas passing through provides information in advance to the control system to support this control.

In the feed forward control, the incoming heat load is calculated by multiplying the gas volume, measured at the stack, by the temperature measured by the inlet of the riser duct. As the desired outlet temperature is known, it is possible to calculate the amount of water required. This value is given as start point for the water control valve. The final adjustment of the water control valve is done by the outlet temperature of the conditioning tower. Large swings in flow or temperature are therefor early detected and can be handled without any problem. The setpoint for the conditioning tower outlet is typically set at 105°C and will be maintained at $\pm 2^\circ\text{C}$ provided the spray lances are properly maintained. The shape of the conditioning tower, along with the positioning of the spray lances and the coverage they provide make for a high residence/retention time of eight seconds that provides sufficient time for the reactions and the water to evaporate.

Figure 3. Control philosophy and instruments of the Conditioning Tower.

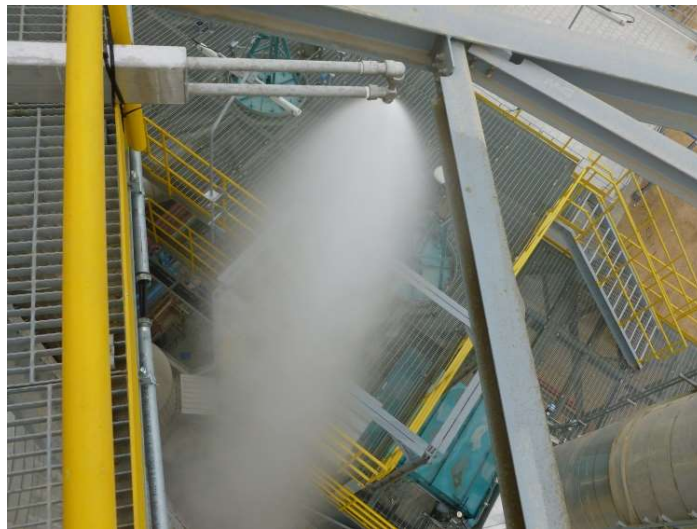
The operational maintenance of the conditioning tower is limited to the inspection of the spray lances. A bi-weekly inspection on the spray pattern of the operational lances is required. All operational lances should be removed and tested one by one. Due to the presence of shut-off ball valves, quick coupling hoses and speedball nuts flanges, the removal of the lances is easy. Once removed, the lance is put on the platform and is reconnected to the hoses and the shut-off valves are opened. The spray pattern should show a plume of mist similar as shown in figure 4A.

Figure 4A. Inspection of lance spray with correct pattern.

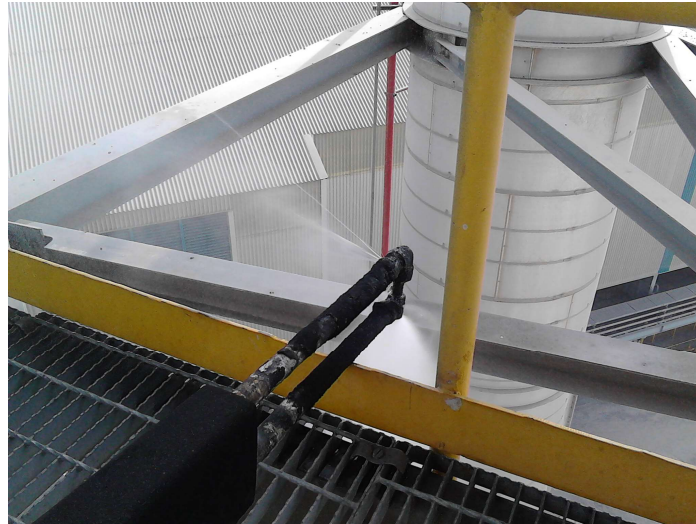
Faulty spray patterns demonstrate sideways spraying or dripping as shown in figure 4B. Such patterns are mostly caused by fouled or corroded lances, an example of which is given in figure 4C. Faulty lances should be cleaned or replaced. After the inspection the lance can be re-inserted and put back in operation. In case of mechanical damage of the nozzle, the tip can be exchanged separately.

Figure 4B. Inspection of lance spray with faulty pattern.

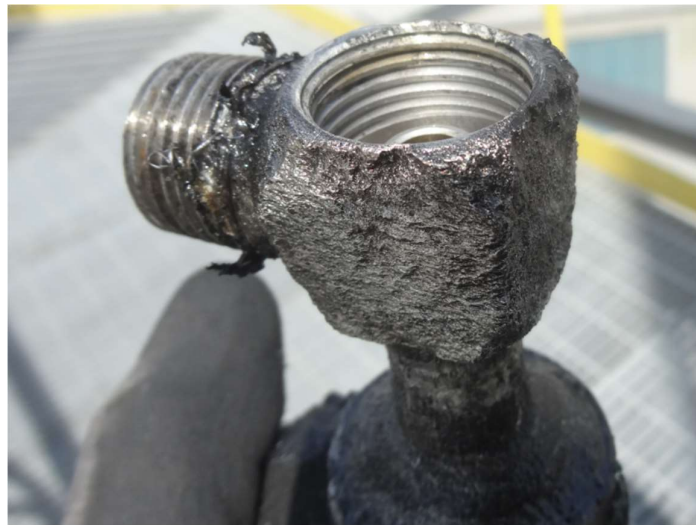
Figure 4C. Fouled spray lance.

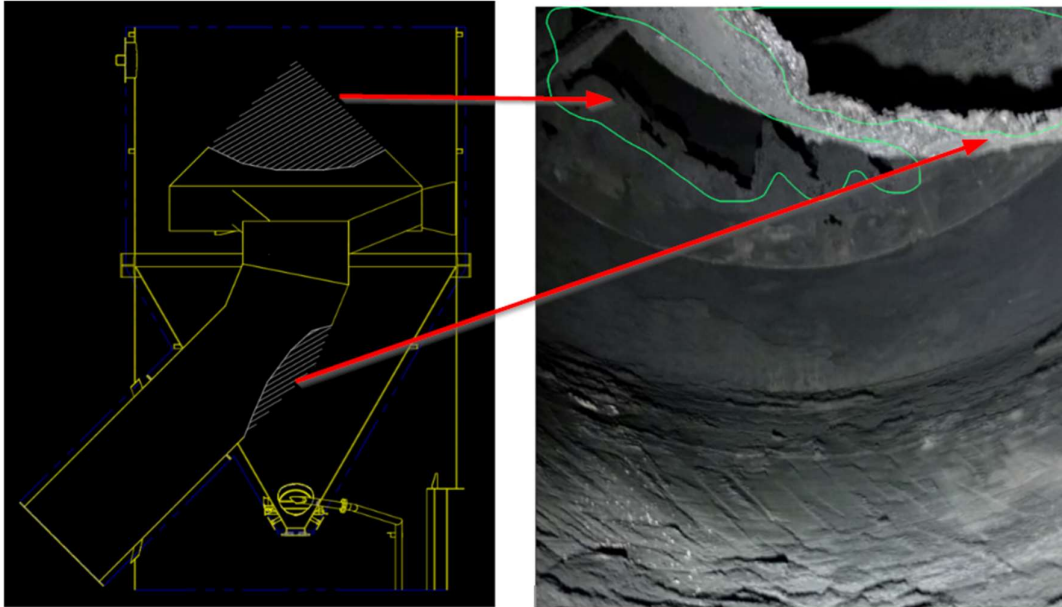
Our conditioning tower has reputation of continued performance in extreme operational ranges, spray lance issues and severe corrosion. During a visit to Plant A, inspection of the conditioning tower showed almost complete loss of the internal diffuser, internal duct and the airlock at the bottom of the conditioning tower as per figure 5 on the next page.

Figure 5. Corroded diffuser cone and internal duct.

With the diffuser out of service, there is potential for hot ambers or large particulate to make its way to the baghouse and cause further damage. This corrosion was direct result of excess spray water caused by compromised spray lances. If the spray nozzle tips are not cleaned, the spray nozzles will suffer corrosion themselves and the injected water is not atomized sufficiently for complete evaporation. Despite the ultra-conservative retention time in the tower, the un-vaporized water droplets collect on the diffuser and cone and ultimately causing corrosion.

We are currently managing a project at Plant A aimed at remediating the conditioning tower. This initiative involves establishing a comprehensive repair strategy, overseeing both the design phase and on-site execution.

The design involves creating an additional supporting system to enable the partial removal of the conditioning tower's supporting skirt. This skirt needed to be cut to allow the installation of three fully assembled parts, minimizing downtime. The second part of the design includes an engineering package for the fabrication and installation of the damaged internal diffuser, internal duct, and a new bottom cone, all provided in complete sizes. The installation will be executed in three phases to ensure a maximum downtime of the conditioning tower of 48 h. Upon completion, the conditioning tower will be restored to its standard condition. Our commitment to the client and our facilities remains of paramount importance to us.

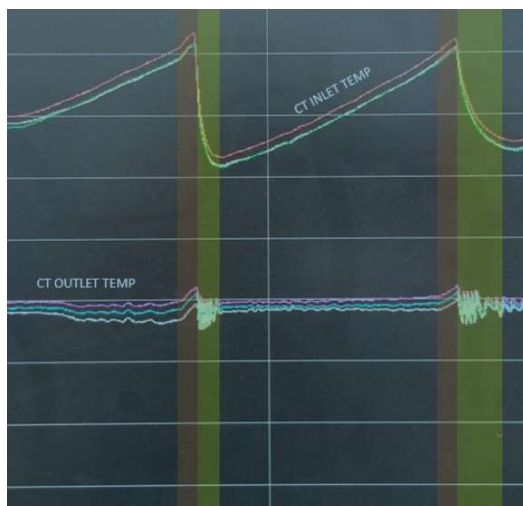
This degree of damage does not happen swiftly and there is ample time during routine maintenance and inspection where this could be easily corrected. However, after years of neglect the extent of corrosion is evident, yet the conditioning tower kept performing for many years. The corrosion continued to grow and yet the outlet temperature from the conditioning tower was generally maintained as can be seen in figure 6: this screenshot shows the inlet and outlet temperatures of the conditioning tower over time and clearly demonstrates that despite major swings in inlet temperature (which is inherent to the nature of the ABF), outlet temperatures remain very stable.

Figure 6. Conditioning tower inlet and outlet temperatures observed during fact finding.
