Hyundai Steel BF3 Bosh Repair

Summary

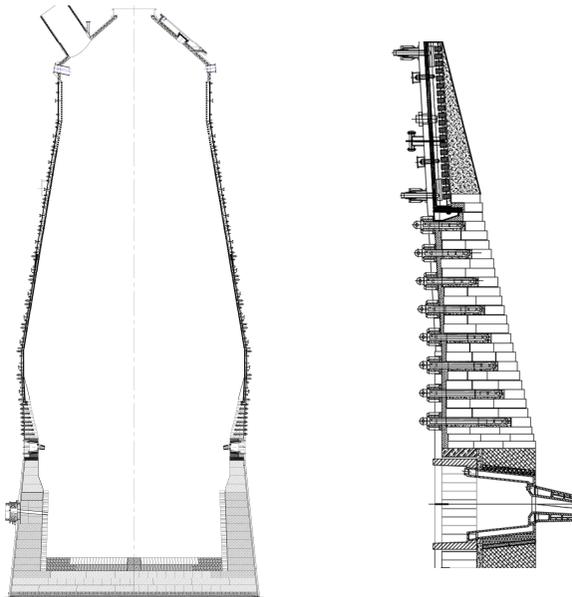
Figure 2: Hyundai Steel BF3 General Arrangement, Tuyere Ring and Bosh Design 2013

BF3 design differs from BF1 and BF2 as these two BF's include copper staves in the bosh. Instead BF3 includes copper plate coolers and silicon carbide in the bosh as this was believed to better protect the tuyere ring due to a more optimum operating profile. However, an optimum operations profile from the bosh copper plate coolers to copper stove coolers needs to be present during the entire campaign. The transition from bosh copper plate coolers to the copper stove coolers in the belly is always challenging as deterioration of the operating profile compromises gas distribution and burden descend. This may cause efficiency and fuel rate penalties.

Deterioration of a silicon carbide bosh lining will furthermore expose the copper plate coolers to aggressive operating conditions. This can cause copper plate coolers deformation and burn-outs. Ultimately the BF shell will be exposed to high temperatures causing hot spots, deformation and cracks. These phenomena have been occurring at Hyundai Steel BF3 and are illustrated in Figure 3.

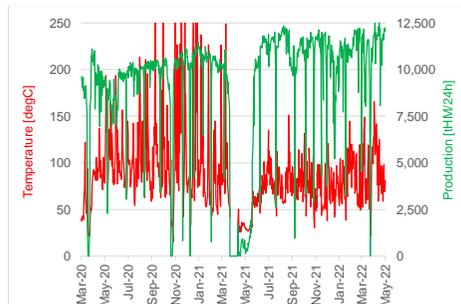
Figure 14: Operating and Monitoring Data 2020 - 2022

Operating and monitoring data before and after the campaign extension repair are illustrated in Figure 14. The production rate could be increased significantly at low bosh refractory temperatures. These temperatures indicate normal to high heat loads in the bosh and are comparable to the FEM analysis results.
